Measured Leak Rate of Ammonia Through an Epoxy/Stainless-Steel Patch

10 August 2007

B. B. BRADY, J. D. DESAIN, and T. J. CURTISS
Space Materials Laboratory
Laboratory Operations

SPACE AND MISSILE SYSTEMS CENTER
AIR FORCE SPACE COMMAND
483 N. Aviation Blvd.
El Segundo, CA 90245-2808

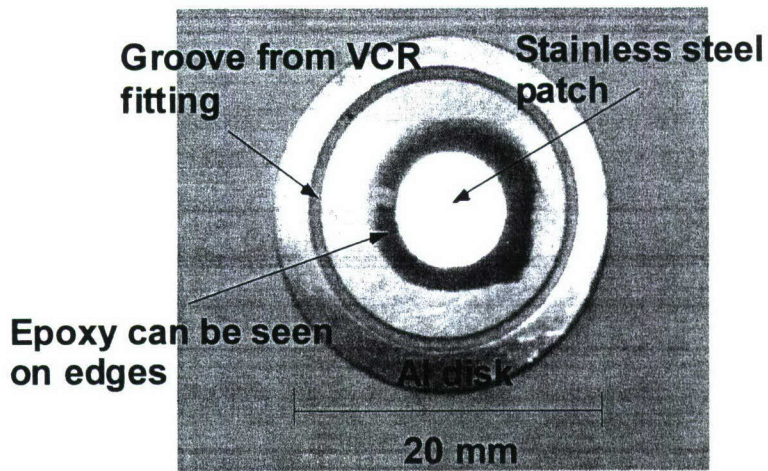
Figure 2.1. A photograph of the aluminum disk used to simulated a patched leaking ammonia heat pipe.

The test articles were prepared from 0.76-mm-thick aluminum disks (20 mm diameter). The aluminum disks were then “patched” as shown in Table 2.1. The patch was a 6.35-mm-dia piece of either stainless steel or aluminum. The patch was adhered to the simulated pipe aluminum disks by several different epoxy methods as shown in Table 2.1. The epoxy layer was measured as approximately 0.25 mm thick. A 0.13-mm (5-mil) hole was drilled into the center of the aluminum disk. To ensure that the drilled hole was completely through the aluminum, but did not penetrate the patch, the drill depth was set at 0.89 mm. This put the end of the drilled hole about midway through the epoxy layer. Three test articles were disassembled at the conclusion of the test to confirm that the drilled holes were completely through the aluminum, but did not penetrate through the patch material. A picture of a prepared aluminum disk is shown in Figure 2.1.

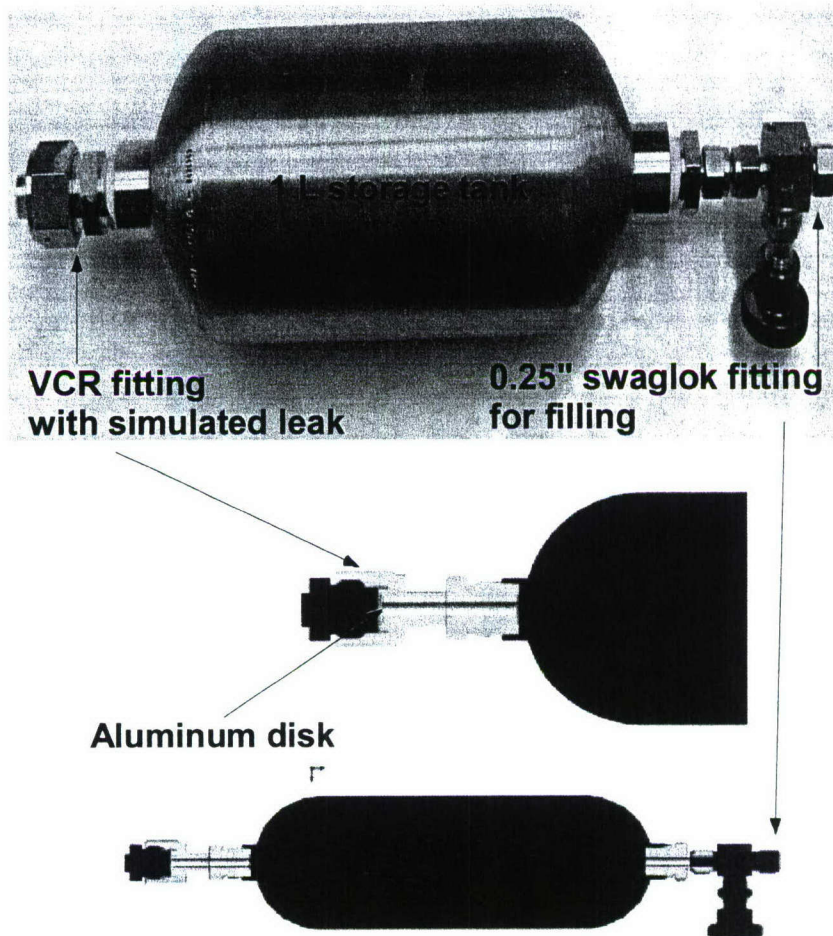
Figure 2.2. Photograph of the ammonia storage tank. The tank volume is 1 L. One end has a valve and a 0.25-in. Swagelok fitting used for filling the tank with ammonia. The other end has a VCR fitting that is used to hold the aluminum disks (used to simulate a patched leaking heat pipe) into place.

A 1-L stainless-steel storage vessel was used as the ammonia test tank (Figure 2.2). After preparation, the test articles were placed into the VCR fitting on the storage tank with the hole side towards the tank interior and the patch material on the outside (air side) of the tank. The VCR fitting was then tightened. The storage tank was then placed on a vacuum line and evacuated to less than 0.01 Torr. The valve was closed on the tank, and the evacuated storage tank was then weighed. The storage tank was then placed back on the vacuum line. The valves to the vacuum line were closed, and the ammo-

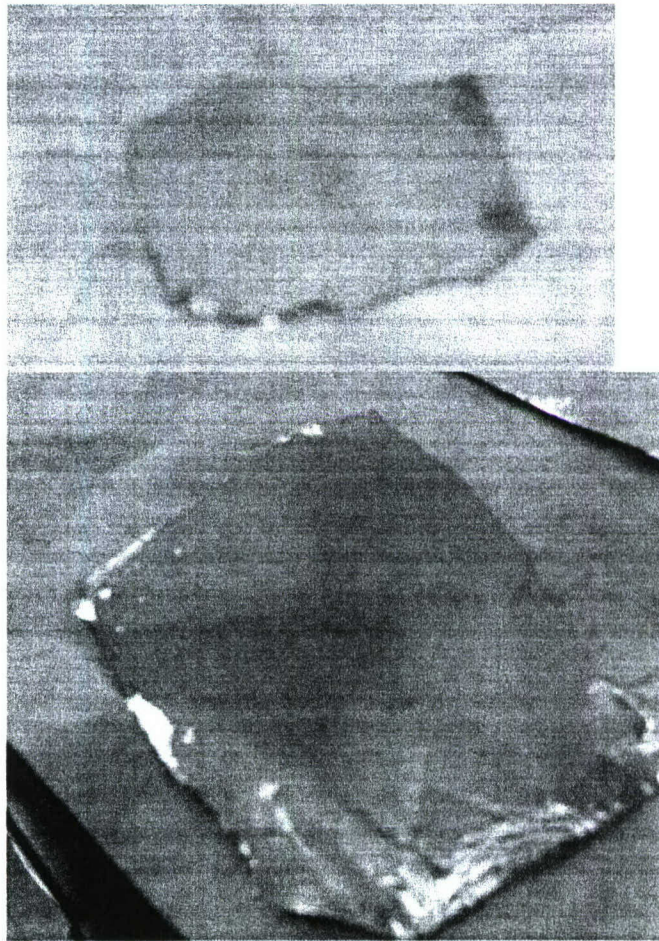
Figure 2.3. Aluminum foil sample that has been painted with ADP and then exposed to ammonia gas. The top picture is directly after removal from a 353K oven. The bottom picture is after returning the foil to room temperature.

over the course of two weeks, a background of ammonia would have built up. Aluminum foil samples placed in the ovens for two weeks also turned blue, consistent with this conclusion. The test blank (test article 15 without a hole) in a separate oven at 353K did not turn blue, indicating that exposure to room air alone will not change the ADP color. Also, several test samples with ADP painted on aluminum foil and left out in lab air over the two-week period did not turn blue. At the end of four weeks, the storage tanks were removed from the oven, and ADP was reapplied. There was no observed color change, indicating that no gross leakage of ammonia from the patches has formed from four weeks of aging.

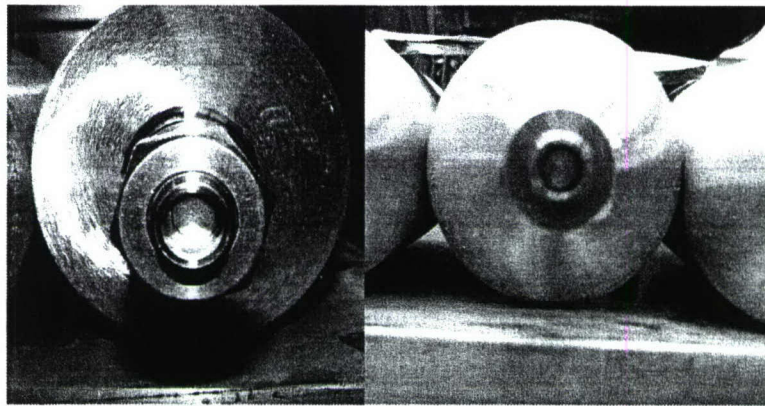
Figure 2.4. A storage tank filled with ammonia before testing for 2 weeks at 353 K. At left the ADP is seen to be yellow indicating no exposure to ammonia. At right the ADP has turned blue indicating exposure to ammonia.

Figure 2.4 shows the color of the ADP of a 353K-exposed sample before and after two weeks of heating. At the two-week point, the ADP paint was removed from the aluminum disks with compressed air. The aluminum disks were then repainted with ADP, but after two days, no color change occurred.

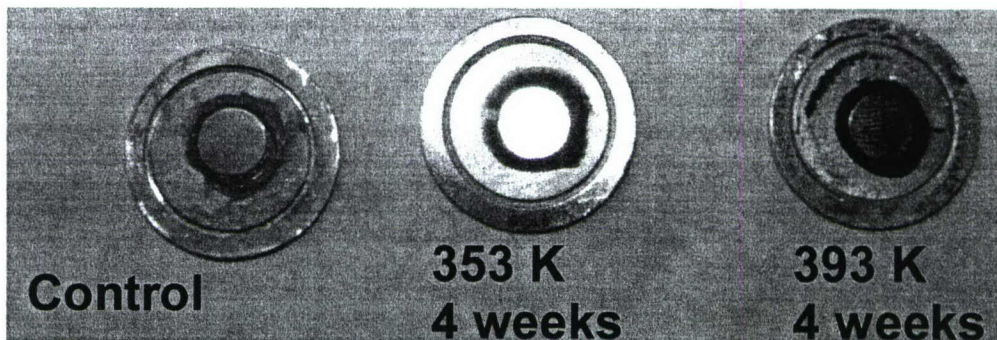
Figure 2.5. Photograph of aluminum disks after testing. The left is the control disk that was not heated, the middle sample was heated to 353K for 4 weeks, and the right sample was heated to 393K for 4 weeks.

The epoxy showed a color change after heating. The control sample remained off-white throughout the four-week study. The epoxy on the samples at 353K for four weeks changed to a tan color. The epoxy on the samples that were placed at 393K for four weeks turned a dark brown. The color change was not correlated with any observed increase in the leak rate from the samples. The color change of the epoxy is shown in Figure 2.5.

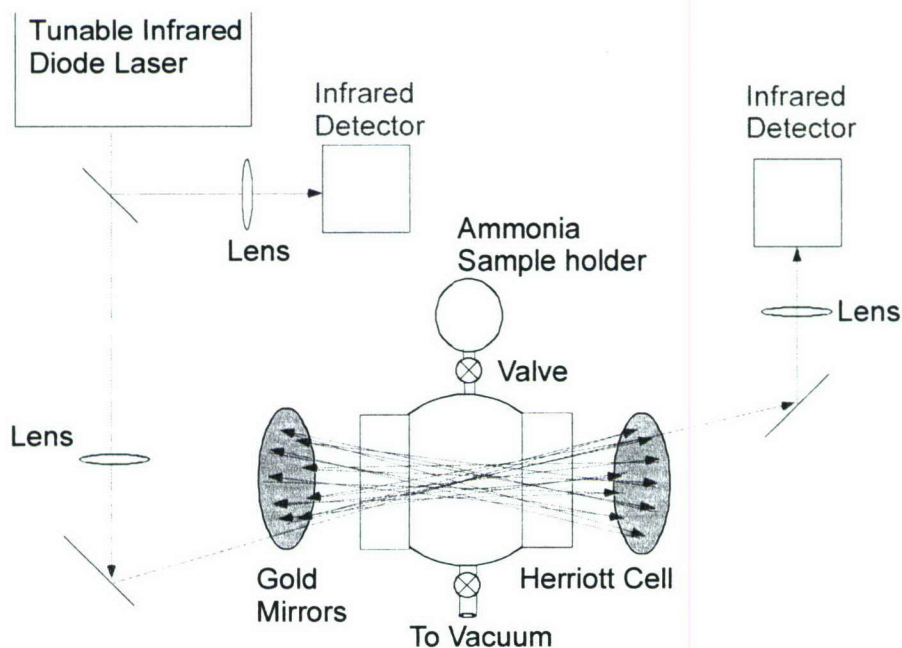
Figure 3.1. The IR laser apparatus setup.

The high-resolution IR absorption of ammonia in the gas phase was used to follow the leak rate of ammonia through the patch over a period of days. A diagram of the IR laser setup used to measure the ammonia storage tank samples is shown in Figures 3.1 and 3.2. The ammonia concentration was monitored using a tunable diode infrared laser. The IR absorption of ammonia was observed at 6691.836 cm^{-1} , the R(6) of the $\nu_1 + \nu_3$ band.¹ The IR probe was split into two beams by a CaF_2 flat. The first beam was directed through a short-focus lens onto an infrared detector (reference). The second beam was directed into a Herriott-type multipass cell.² The cylindrical cell (volume 142 cm^3) was 10 cm long with a 2 cm radius, and has anti-reflective-coated windows. The multipass cell is usually set up to perform 63 passes. The total path length of the infrared laser in the multipass cell is $\sim 630\text{ cm}$. After exiting the cell, the second beam was directed through a short-focus lens onto an infrared detector (signal). The laser frequency was then tuned over an ammonia absorption feature. In order to reduce laser noise in the ammonia signal, the absorption was monitored as the difference between the balanced signal and reference detectors.

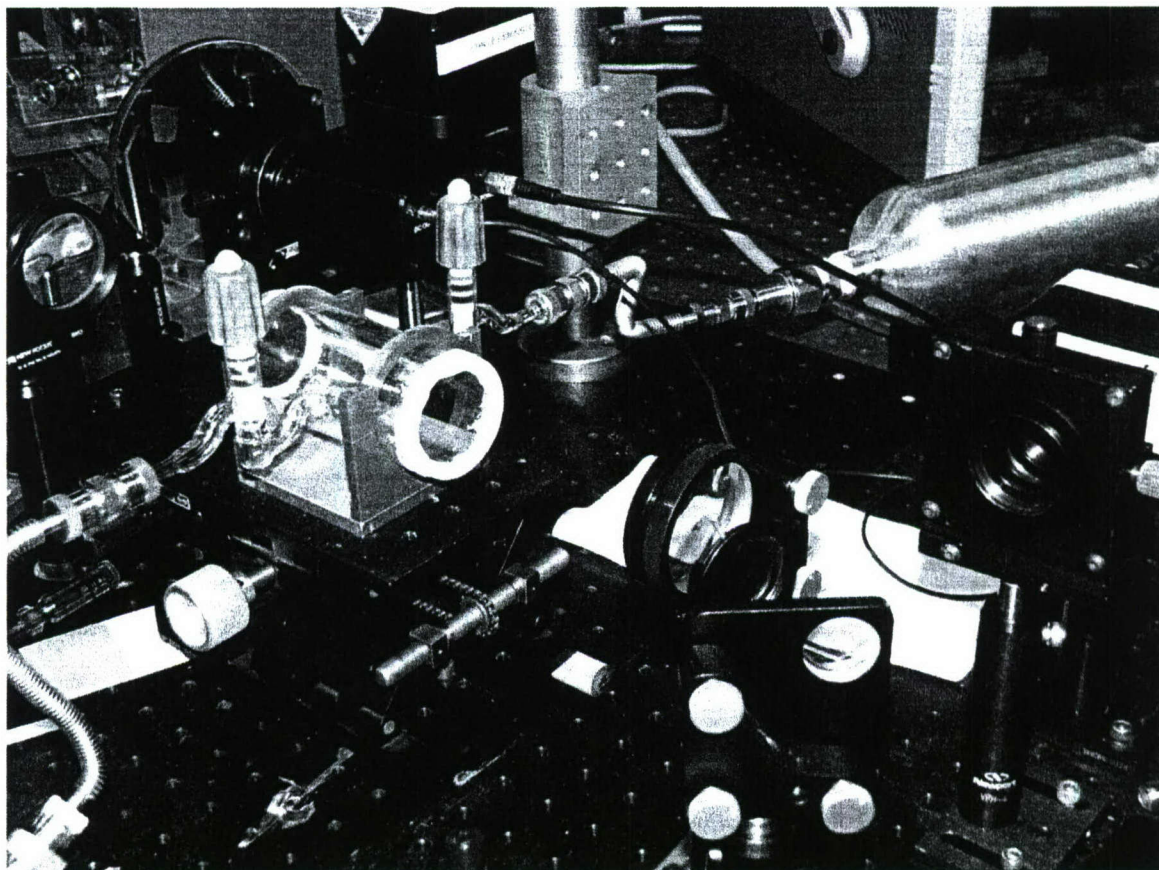
Figure 3.2. Photograph of the IR laser absorption experimental setup.

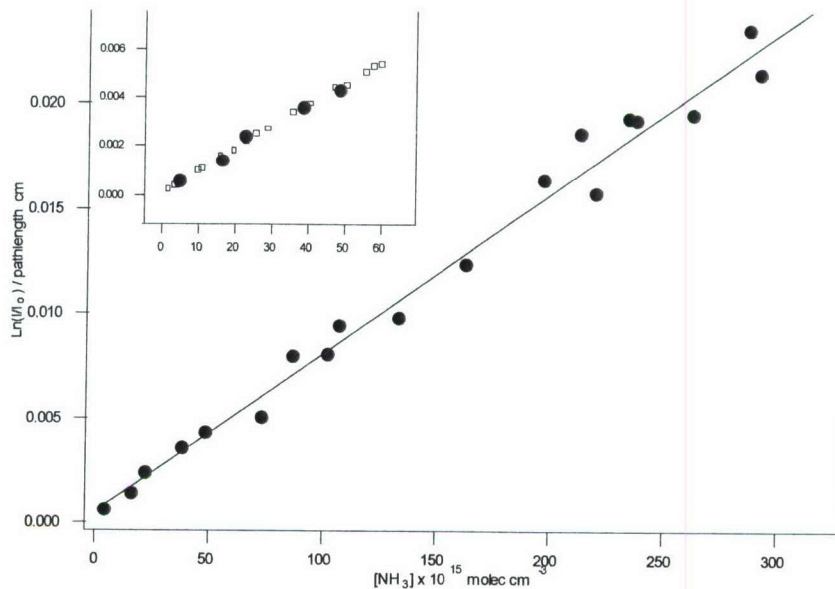
Figure 3.3. The absorbance of the IR laser divided by the path length vs. the ammonia concentration. The slope corresponds to an IR cross-section of $\sigma_{\text{IR}} = 7.6(\pm 0.4) \times 10^{-20} \pm 0.4 \text{ cm}^2$.

the cross section to be $7.28 \times 10^{-20} \text{ molec}^{-1} \text{ cm}^2$ at 294.15K. Figure 3.3 shows the observed absorption of the ammonia transition at different ammonia concentrations using a 30-cm path length and a 151-cm path length. The cross section can be obtained from the slope of a linear fit to the data in Figure 3.3 using the Beer-Lambert law;

where I is laser intensity and L is the path length. The slope yields a cross section of $\sigma_{\text{IR}} = 7.6 (\pm 0.4) \times 10^{-20} \pm 0.4 \text{ cm}^2$. This is in good agreement with the previous measurement.

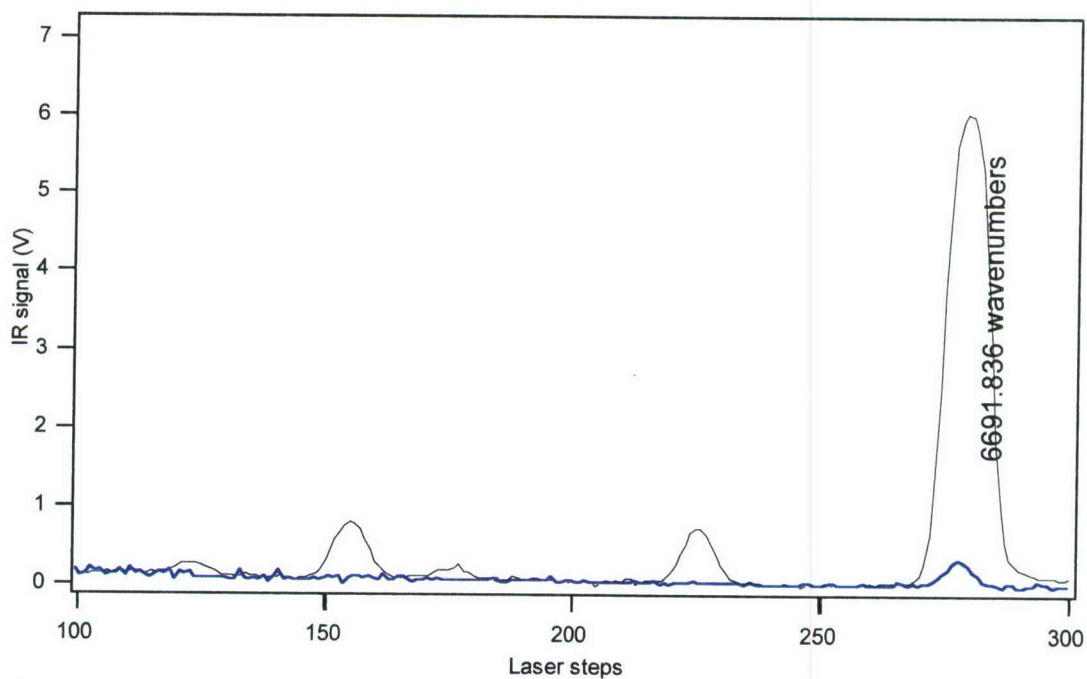
Figure 3.4. The IR absorption of ammonia spectrum around 6691.836 cm^{-1} . The black spectrum was a test spectrum done with 0.9 Torr of ammonia in the cell. The blue spectrum was taken after sample tank 16 leaked into the cell for 67.25 hrs.

Figure 3.4 shows the infrared spectrum of ammonia with 0.9 Torr of ammonia in the test cell (black). Also shown is the infrared spectrum of ammonia for test sample tank 16 after leaking into the test apparatus for 67.25 h. Equation (3.1) was used to determine the amount of ammonia present from the ammonia infrared signal. The signal in Figure 3.4 corresponds to an increase in ammonia of $3.19 \times 10^{14} \text{ molec cm}^{-3}$ in the cell.

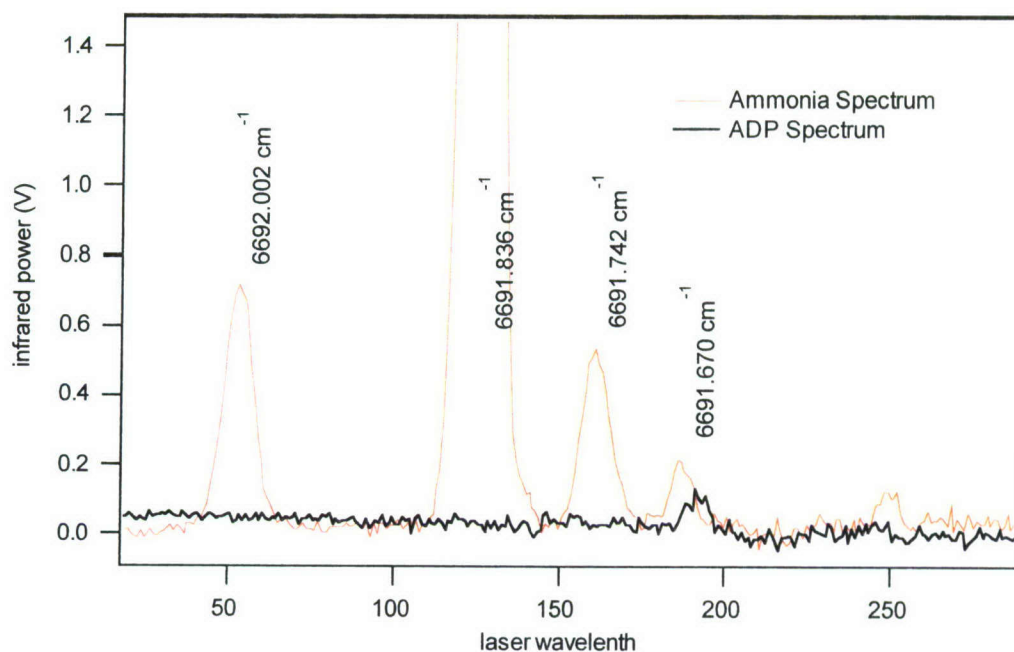
Figure 3.5. The IR absorption of the ADP spectrum around 6691.6 cm^{-1} . The red spectrum was taken with ammonia in the test cell. The black spectrum was taken of the out gassing from an aluminum foil sample that had been sprayed with ADP and not exposed to ammonia.

The ADP was observed to outgas off the surface of the storage tanks. The ADP outgassing product has an absorption peak near the ammonia peak used to monitor the experiment (Figure 3.5). The peaks are far enough from each other (in wavelength) so as not to cause interference. Figure 3.6

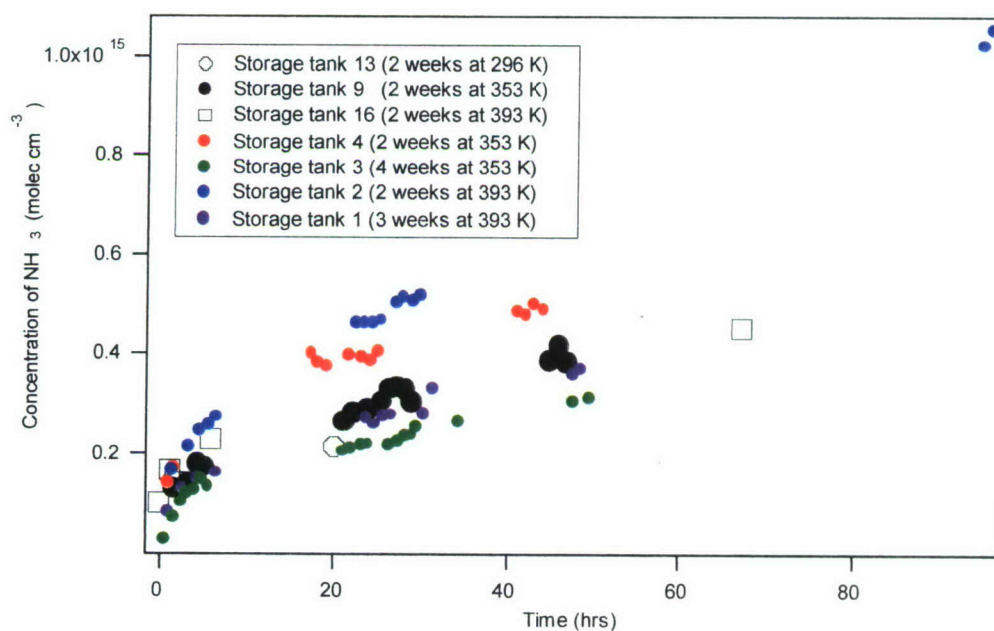
Figure 3.6. The observed increase in ammonia in the test cell for 7 different test samples. The (\circ) sample was kept at room temperature, the (\bullet) sample was stored for 2 weeks at 353K and the (\square) sample was stored for 2 weeks at 393K, the red (\bullet) sample was stored for 2 weeks at 353K, the green (\bullet) sample was stored for 4 weeks at 353K, the blue (\bullet) sample was stored for 2 weeks at 393K and the violet (\bullet) sample was stored for 3 weeks at 393K. The leak rates of ammonia for the three samples were all observed to be similar.

shows the increase in ammonia with time for test tanks 1, 2, 3, 4, 9, 13 and 16. After the initial first day of outgassing from the walls of the test cell, the amount of ammonia increased linearly with time over several days, corresponding to leak rates shown in Table 3.1. There is no significant difference in the leak rate between the samples with (9,13 and 16) and without (1, 2, 3, 4) the primer. An extra week of storage at 393K (1) or two weeks at 353K (3) had no significant effect on the measured ammonia leak rate.

As seen in Figure 3.6, the leak rates of the seven samples were all very similar. There was no significant effect of storage in an ammonia environment for 2, 3, or 4 weeks at either 353K or 393K on the ability of the patches to prevent ammonia from leaking through the simulated hole. The average leak rate in Table 2.2 corresponds to a loss of 0.16 ± 0.04 mg of ammonia annually from the simulated primed patched-hole samples. The patch sample without the primer had a slightly larger leak rate, which corresponds to a loss of 0.19 ± 0.04 mg ammonia annually.
